### SAMPLE TRACK REHABILITATION REPORT

#### D-2. Railroad Track Rehabilitation Report for Fort Example Summary.

**SAMPLE RAILROAD TRACK REHABIUTATION REPORT  
FOR  
FORT EXAMPLE**

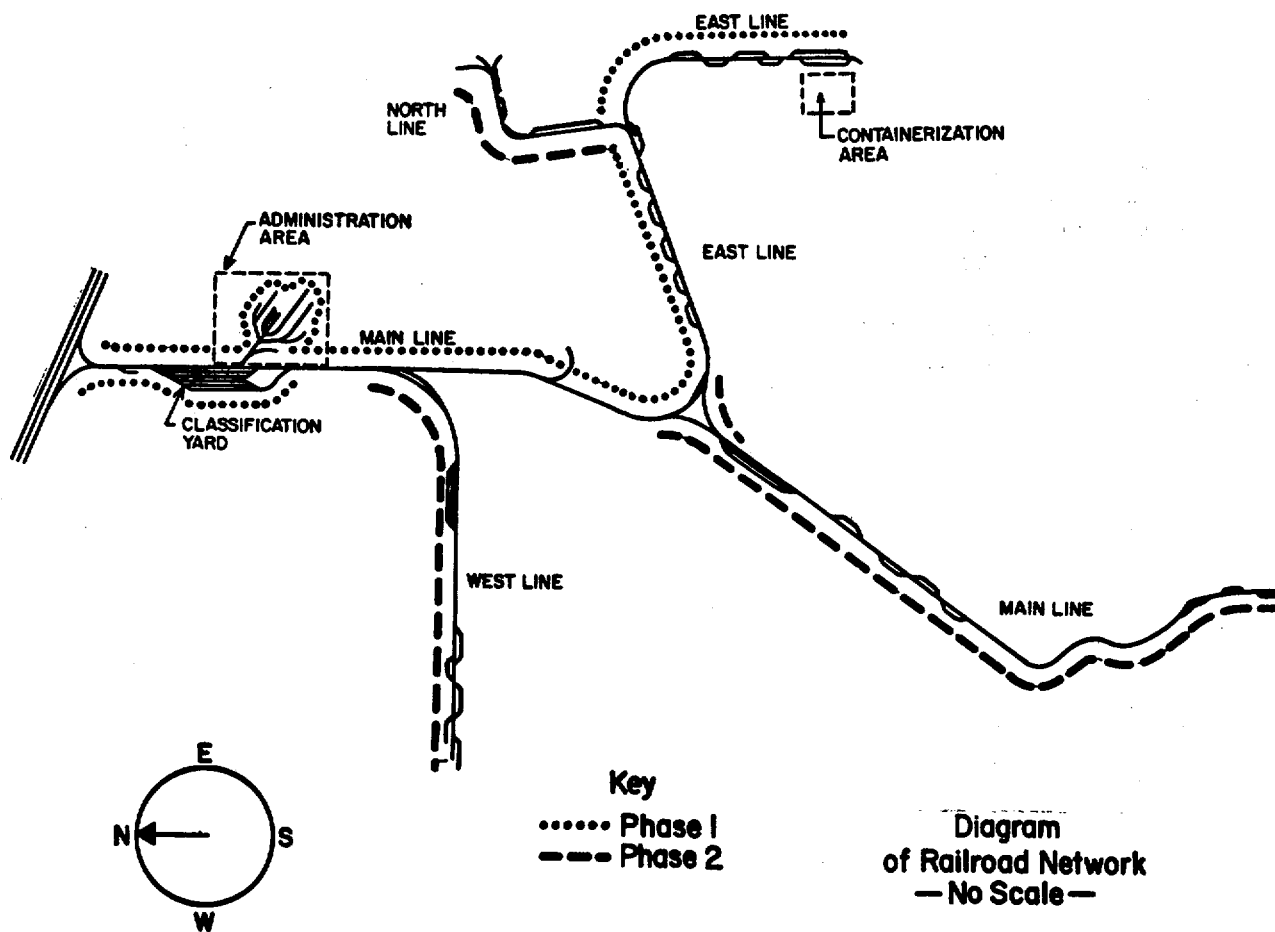
Figure D-1. Track Diagram for Fort Example.

The railroad network connects with the (Railroad Name) Railway about 10 miles east of (City, (State). Of the 19.95 miles of track, 9.62 miles are primary routes, 3.43 miles are in the classification yard, and 6.90 miles are loading and storage sidings and auxiliary tracks. A track diagram is shown in figure D-1, with a key to track designations in table D-1.
